SIGN13 – Information Sheet

CER Checklist item: SIGN13

The sign "WARNING: HAZARDOUS d.c. VOLTAGE Solar d.c. cables in conduit have been installed in this ceiling space. The conduit is labelled 'SOLAR' and care must be taken while working nearby. The internal solar d.c. cables may be live and must not be disturbed or damaged" is missing or incorrectly displayed.

Standard reference: AS/NZS5033:2021 5.3.1.2

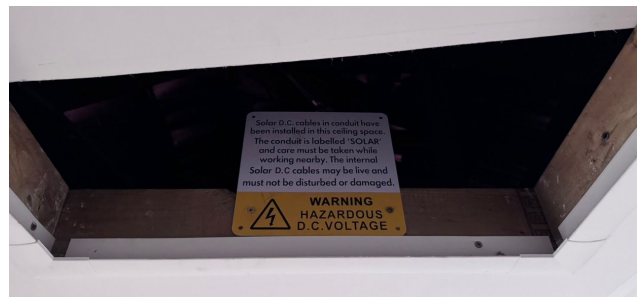
Figure 1: A compliant label installed adjacent to the access point of an accessible roof space.

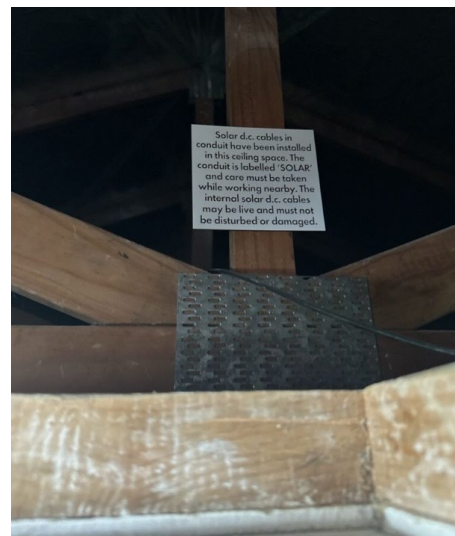
- a) **Non-compliance:** It is frequently observed that installers fail to install the required warning label in conjunction with the “Cables in the ceiling” label, as illustrated in Figure 3 and Figure 4. While some labelling manufacturers supply these warnings as separate labels to simplify production, it remains the installer’s responsibility to ensure that both labels are correctly installed within the roof or ceiling space where disconnection points are used as the isolation method.

In some cases, these labels are incorrectly installed at the main switchboard, or are not installed at all, resulting in non-compliance.

Figure 3: Non-compliant: the label does not contain the **WARNING: HAZARDOUS d.c. VOLTAGE** portion of the label.

Failure to install the appropriate warning signage presents a significant safety risk to anyone entering roof or ceiling spaces where photovoltaic (PV) d.c. cabling is present. This risk is particularly relevant for other tradespeople who may be unaware of the presence of PV wiring while undertaking work in these areas.

PV d.c. cabling is not protected by circuit protection devices and, in domestic installations, may operate at voltages of up to 1000 V d.c. As such, this cabling and any associated enclosures must not be disturbed under any circumstances.

- b) **Best Practice:** To ensure compliance, both labels (where not supplied as a combined label) must be securely fixed adjacent to the under floor or roof space access point, in a position that is clearly visible to anyone entering under floor or the roof space. Where a property has multiple under floor or roof space access points, a compliant label in accordance with AS/NZS 5033:2021 Clause 5.3.1.2 must be installed at each access point, ensuring that any person entering is adequately warned of the hazards associated with PV d.c. wiring.

It is considered best practice to keep an adequate supply of these labels in the work vehicle. Failure to install the required labels at each access point may result in a defect being raised during audit or inspection, requiring a return visit to the site to rectify the non-compliance.

Labels should be positioned thoughtfully and fixed to a suitable adjacent surface; placing them directly on the manhole cover is discouraged and is generally considered aesthetically unacceptable.
