# SIGN14 – Information Sheet

### CER Checklist item: SIGN14

Where a “Disconnection Point” has been provided, the sign “WARNING: LOADS MUST BE ISOLATED AND CIRCUIT MUST BE TESTED FOR THE ABSENCE OF CURRENT BEFORE UNPLUGGING” is not attached to both the positive and negative cable within 100 mm of the disconnection point of the PV string, or the minimum text size is 10 mm.

**Standard reference:** AS/NZS 5033:2021 Clause 5.5.2.2.

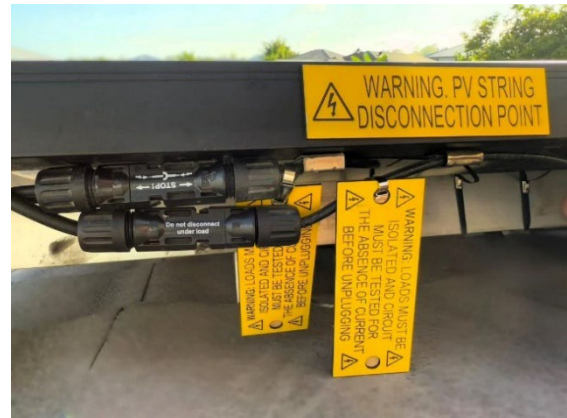
**Figure 1: Compliant Warning labels applied to both positive and negative cables within 100mm of the disconnection point, using stainless steel ties.**

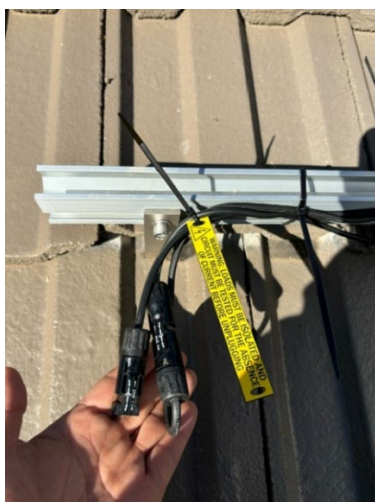
*Figure 3: One label used across both conductors, fixed with plastic ties, this is non-compliant.*

- a) **Non-compliance:** It is frequently observed, as shown in Figures 3 and 4, that installers are not correctly applying warning labels to both the positive and negative cable. Installing a single label across both cables is non-compliant. In addition, some installers are using plastic cable ties to secure labels; these are unsuitable for the installation environment, as they degrade under UV exposure and may fail over time.

Where a label is missing, incorrectly fixed, or has detached due to inadequate securing methods, it becomes difficult to clearly identify the disconnection point and determine which conductors must be disconnected to safely isolate the PV string.

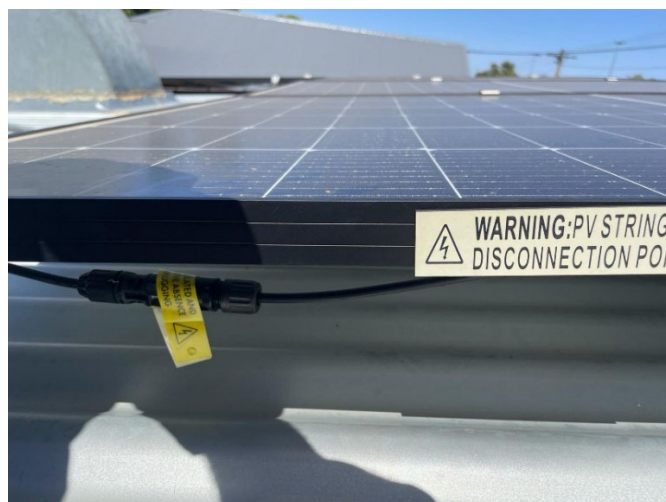
*Figure 4: With one label across the disconnection point and the label not durable for the location, this is non-compliant.*

Figure 4 illustrates a label affixed across the disconnection point itself, preventing operation unless the label is first removed. This arrangement is non-compliant with multiple requirements of the CER inspection checklist and undermines the intended function of the warning label.

Furthermore, the labels shown appear to be of substandard quality and may not be suitable for the expected operational life of the system, increasing the likelihood of deterioration, loss of legibility, or complete failure over time.

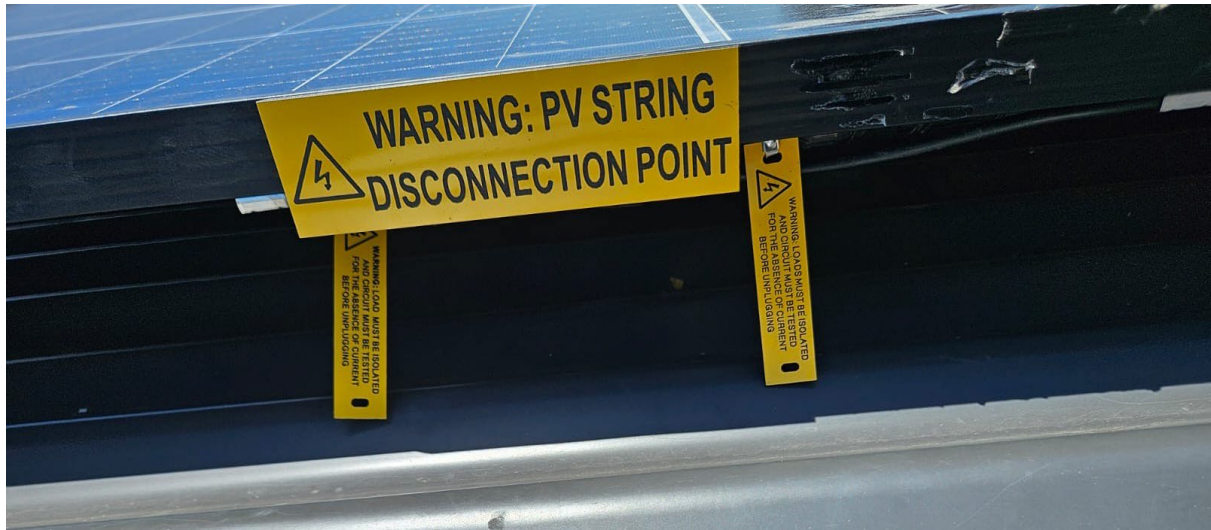
**Figure 5: Compliant Labels correctly applied to both the positive and negative cable within 100mm of the disconnection point using stainless steel ties. Labels are UV stable and engraved.**

- b) **Best Practice:** Understanding both the requirements of the standard and the purpose of this warning label is essential to maintaining compliance. A warning label must be fixed to both the positive and negative cable, within 100mm of the disconnection point, using stainless steel cable ties, as shown in Figures 1 and 5. One label is required per conductor; a single label applied across both cables is not acceptable.

To ensure long-term compliance, SAA recommends the use of UV-stable, engraved multi-layer plastic labels (commonly referred to as Traffolyte) or equivalent materials. Labels must be suitable for the expected operational life of the system and capable of withstanding harsh environmental conditions without loss of legibility or durability.
