SIGN3.1 – Information Sheet

CER Checklist item: SIGN3.1

If the solar system is connected to a distribution board, the following sign is located on the main switchboard and all intermediate distribution boards "WARNING MULTIPLE SUPPLIES ISOLATE INVERTER SUPPLY AT DISTRIBUTION SWITCHBOARD AT (LOCATION)".

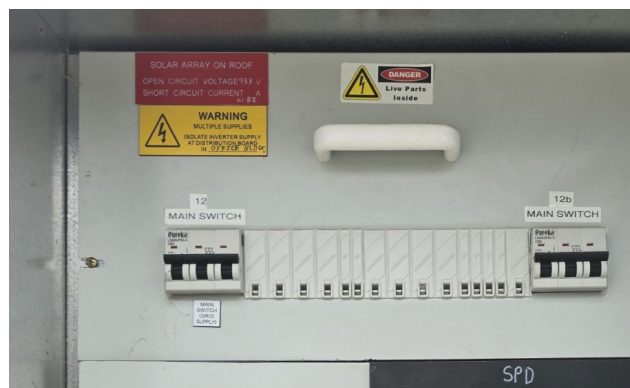
Figure 1: 'Warning Multiple Supplies' label has been compliantly installed at the MSB indicating the location of the distribution board to isolate the inverter supply.

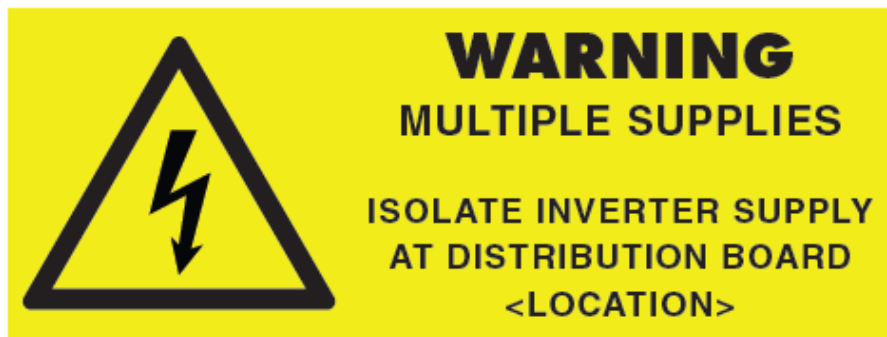
Figure 2: Example of a compliant sign for a main switchboard or distribution switchboards when the IES is connected to a subsequent distribution switchboard. Location information to be included at time of installation.

NOTE An example is provided in Appendix A.

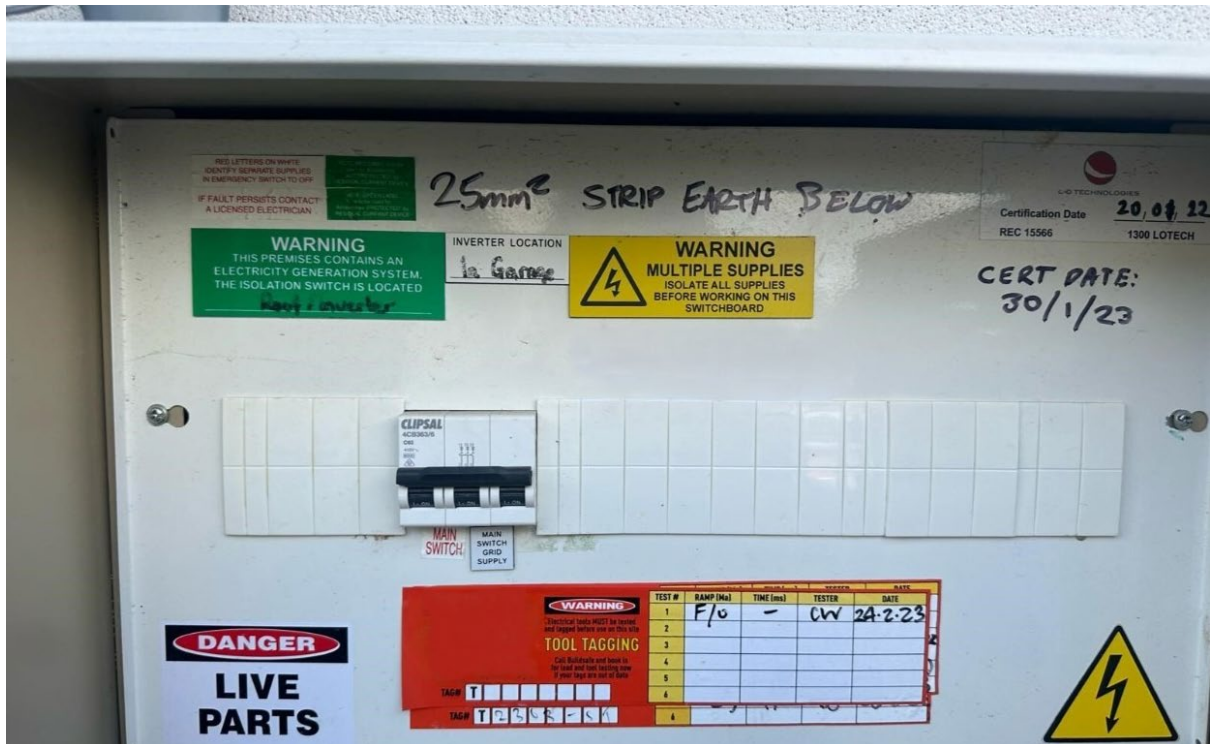
Figure 3: Incorrect 'Multiple supplies' label applied.

- a) **Non-compliance:** It is commonly observed that installers incorrectly apply the “Multiple Supplies” label without identifying the distribution switchboard to which the IES is directly connected, as required by AS/NZS 4777.1:2024 Clause 6.4 (see Figure 3).

Labels that do not clearly specify the location of the distribution switchboard supplying the inverter fail to meet the intent of the Standard and do not provide adequate guidance for safe isolation.

- b) **Best Practice:** Installers should use the prescribed “WARNING MULTIPLE SUPPLIES” label format and clearly specify the exact location of the distribution switchboard to which the IES is directly connected. Labels should be completed legibly, permanently fixed at the main switchboard and all relevant intermediate distribution boards, and verified during commissioning and handover to ensure emergency services and maintenance personnel can quickly and correctly isolate the inverter supply.
