# SIGN 7.2.1 – Information Sheet

### CER Checklist item: SIGN 7.2.1

A 100 mm diameter circular green reflector PV sign with the letters AC , DP, or SW indicating the isolation method is not installed or is incorrectly installed on or adjacent to the meter box and switchboard, or is not readily available to be seen by approaching emergency workers.

**Standard reference:** AS/NZS 5033:2021 Clause 5.4

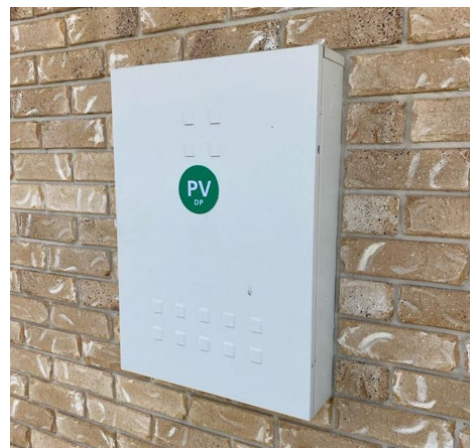
**Figure 1: Compliant Fire and emergency information label displaying 'DP' as the method of isolation used at the PV array.**

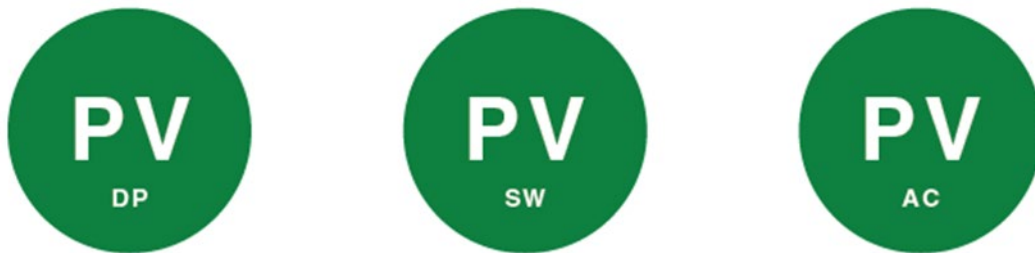
**Figure 2: Example of signs for fire and emergency information.**

PV systems shall have a circular green reflector sign at least 100 mm in diameter with the letters “PV” on or immediately adjacent to the main metering panel and main switchboard, to be readily visible to approaching emergency workers. Below the “PV” lettering shall include the following:

- a) “AC ” - For inverters where the calculated PV d.c. circuit maximum voltage is less than 120 V d.c. at the inverter PV input, and the PV modules are within 1.5m of the inverter are installed.
- b) “DP” – Where a disconnection point is used as the isolation method.
- c) “SW” – Where a load break disconnection device is used as the isolation method.

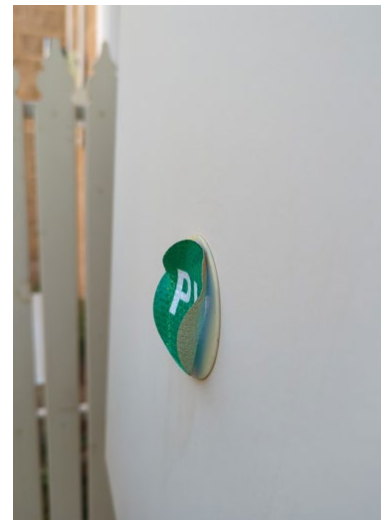
- a) **Non-compliance:** Poor-quality labels are prone to early failure, as shown in Figure 3. These labels commonly peel away from their backing over time and may ultimately detach completely.

When labels fail or are missing, the main switchboard is left without a clear and reliable indication of the PV array disconnection method. This compromises the ability of emergency services personnel to quickly and correctly identify the isolation method, increasing risk during emergency response situations and undermining the intent of the labelling requirements.

**Figure 3: Non-compliant as label not sufficiently durable for the lifetime of the system.**

- b) **Best Practice:** Ensure you purchase labels from a reputable seller, and that labels are tested in accordance with the Australian standards.

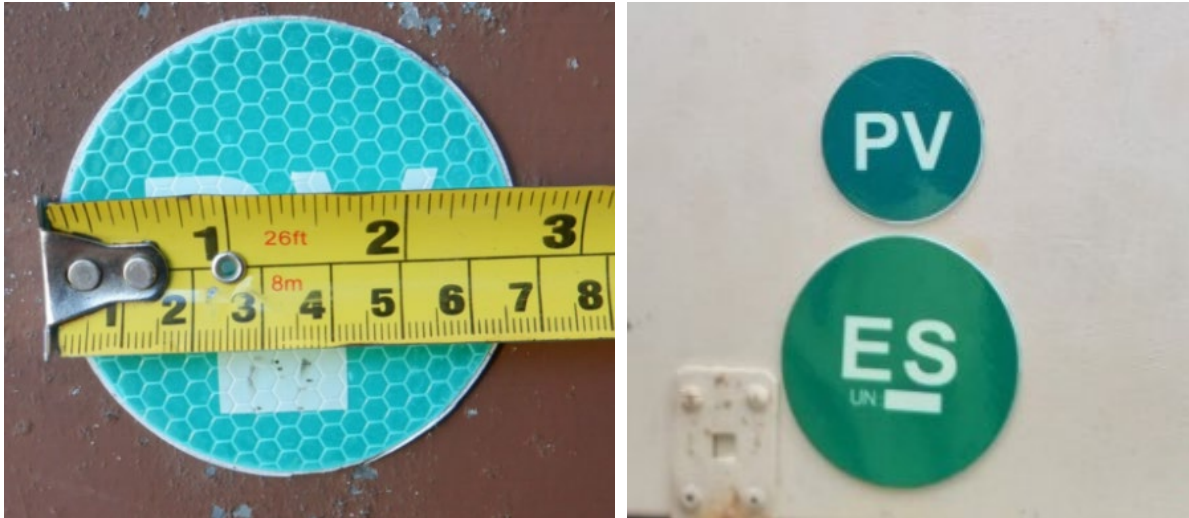
**Figure 4: Non-compliant as the label must be at least 100 mm in diameter.**

- a) **Non-compliance:** It is commonly observed that installers leave the existing green PV label in place when upgrading or replacing an existing system. These legacy labels are **non-compliant with current standards**, as they are typically **70 mm in diameter**, whereas the standard requires a **minimum diameter of 100 mm**.

In addition, older labels do not provide the ability to clearly identify the **disconnection method used at the PV array** (e.g. AC, DP, or SW). The absence of this information reduces the effectiveness of the label and fails to provide emergency services personnel with clear and unambiguous guidance on the correct isolation method.

When undertaking system upgrades or replacements, installers must ensure that all PV identification labels are replaced with labels that fully comply with current requirements, including correct size, visibility, and accurate identification of the PV array disconnection method.

- b) **Best Practice:** Ensure labels are replaced and meet the current standards, including all key requirements within this document.

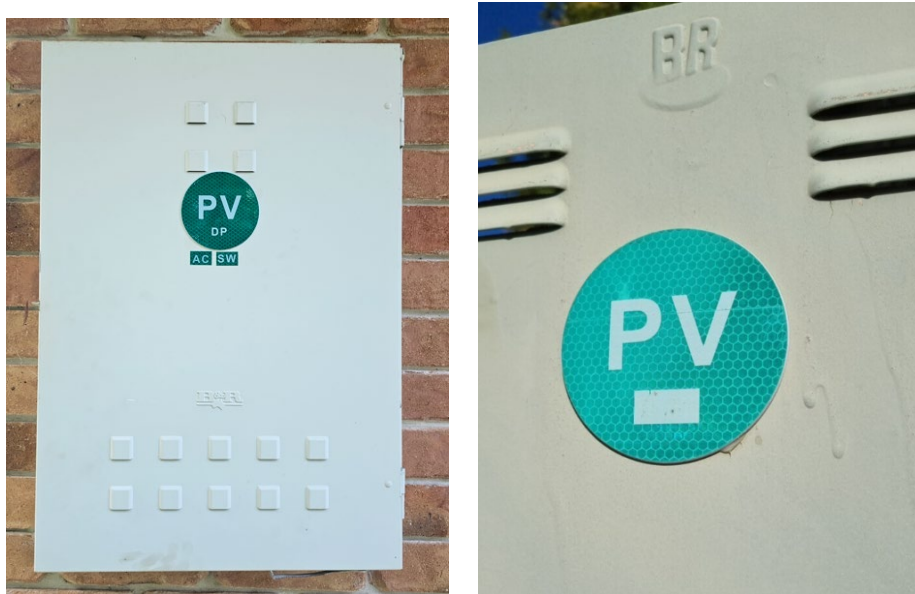
**Figure 5: Non-compliant due to incorrect identification of disconnection method used at the PV array.**

- a) **Non-compliance:** It is frequently observed that installers incorrectly apply **all disconnection method options** beneath the “PV” text on the green reflector label. This approach is non-compliant, as it does not clearly identify the **actual disconnection method used at the PV array**, reducing the effectiveness of the label for emergency services personnel.

In other instances, the incorrect disconnection method has been selected, or the field has been left blank altogether. These outcomes fail to provide clear and unambiguous guidance on how the PV system is to be safely isolated and may result in a defect being recorded during inspection.

- b) **Best Practice:** Installers should ensure that **only the correct disconnection method** used at the PV array (AC, DP, or SW) is clearly identified beneath the “PV” text on the green reflector label. Where labels provide multiple options, all unused options should be removed, covered, or left unmarked. Labels that use stickers or allow for marking with a handheld engraver should be completed accurately and legibly to ensure emergency services personnel can immediately and confidently identify the correct isolation method.
